OPERATING EXPERIENCE WEEKLY SUMMARY

Office of Nuclear and Facility Safety

March 26- April 1, 1999

Summary 99-13

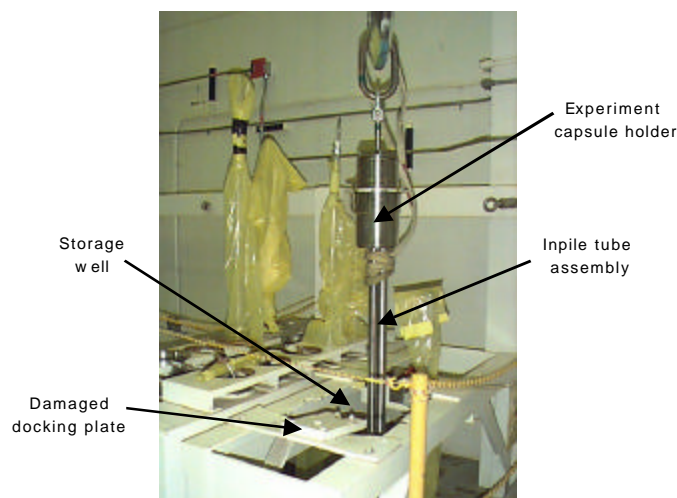
Workers had uprighted the inpile tube assembly and strongback, stored them in a temporary storage well, disconnected the inpile tube assembly from the strongback, and docked the strongback in a docking plate. The docking plate held the strongback in place by gravity and locating pins. The riggers were moving the inpile tube assembly from the temporary storage well into another storage well when it snagged the strongback and lifted it up enough to dislodge the strongback from its docked position (see Figure 1-2). Investigators determined that the 400-lb inpile tube assembly was new and was being prepared for initial installation in the Advanced Test Reactor. They conducted a preliminary inspection of the inpile tube assembly and did not identify any damage to it. However, because the inpile tube assembly supported the weight of the strongback during this event, investigators believe that it may have been overstressed. They will further inspect it to determine if it was damaged.

Figure 1-1. Inpile Tube and Damaged Docking Plate

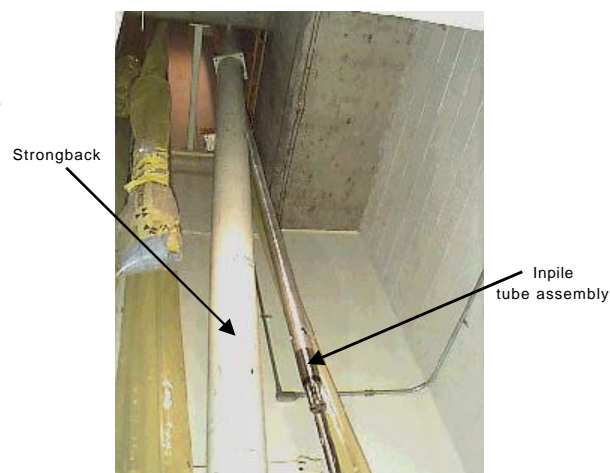
Figure 1-2. Strongback and Inpile Tube

Facility managers stopped all facility activities and held an emergency recovery meeting to determine how to proceed. They isolated the storage area fire water system and implemented compensatory measures because the top of the strongback is leaning against a 1½ inch fire
